WINCAN AMERICA INC
 320 SORTAIS ROAD
 DURANGO, CO 81301
 Tel: 970.259.4842, Fax: 970.247.5033

INSPECTION REPORT

DATE: 02/01/00	WORK #: AM-020100	WEATHER: SUNNY, DRY	OPERATOR: B. GREEN	SECTION NR: 17	SECTION NAME: 235159263
PRESENT: INS. SMITH	VEHICLE: #30	CAMERA: PAN/TILT	PRESET: 2.5	CLEANED: MEDIUM	RATE: 16

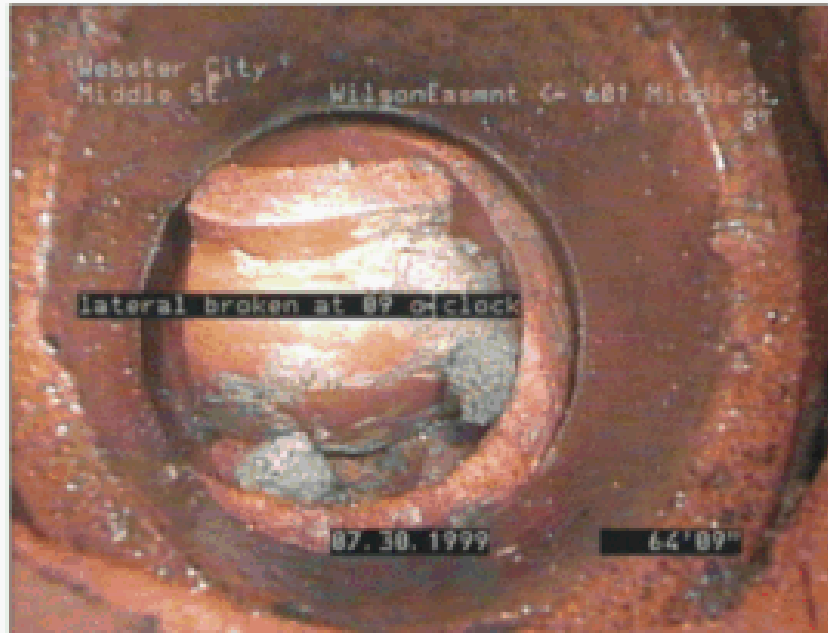
IMAGE: 11_4a, TAPE #: 1, 01:44:24
lateral broken at 09 o'clock

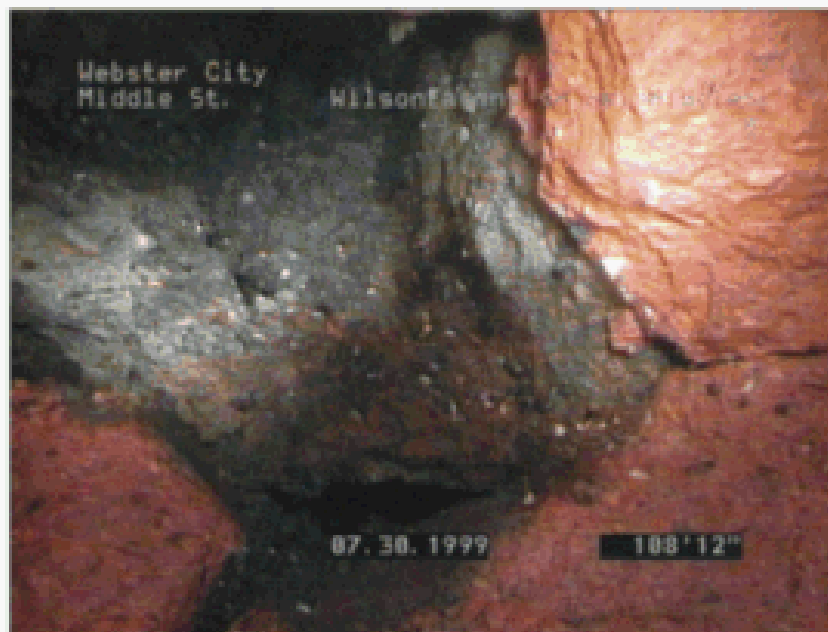
IMAGE: 11_4b, TAPE #: 1, 01:44:24
lateral broken at 09 o'clock

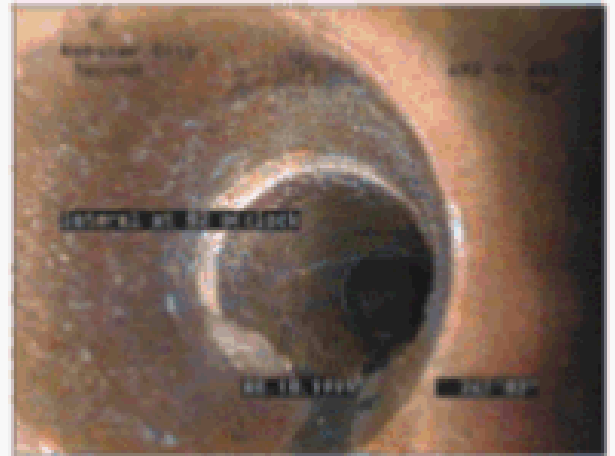
IMAGE: 35_16a, TAPE #: 6, 01:37:36
lateral at 02 o'clock

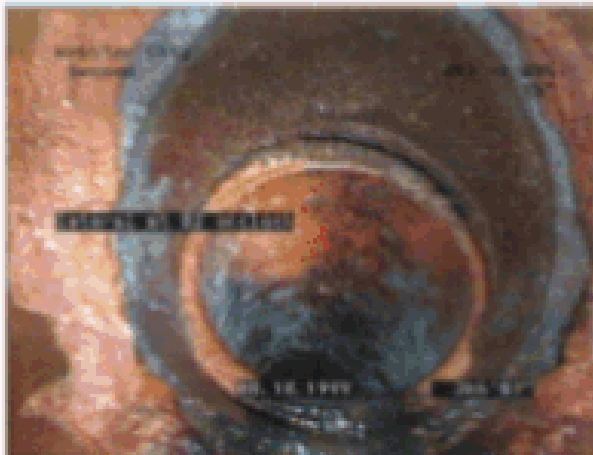
IMAGE: 35_20a, TAPE #: 6, 01:40:20
lateral at 02 o'clock

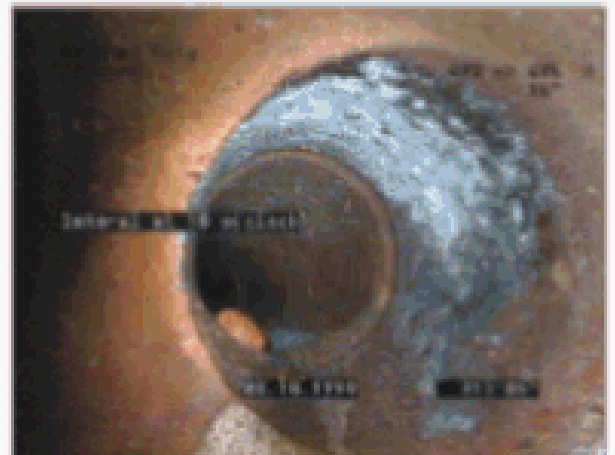
IMAGE: 35_23a, TAPE #: 6, 01:43:11
lateral at 10 o'clock
