Smoke Test - City of Westberg

City of Westberg

Westberg, OR

12/21/2001

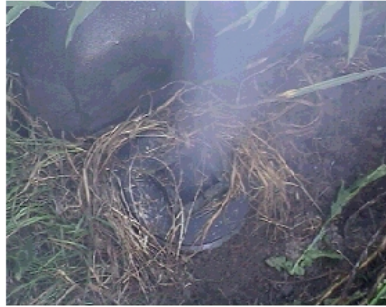
Image : 225 E 10th St

Category: Cleanout

Video Ref: 01600 **Severity:** 2

Location: 225 E 10th St

Description: There is broken cleanout cap on the side of the house. Two vents on the back of the house could be extended above the roof line.

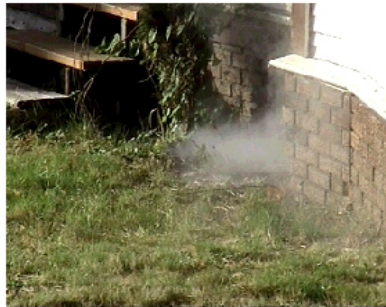
Image : 248 E 10th St

Category: No venting

Video Ref: 01602 **Severity:** 2

Location: 248 E 10th St

Description: This house has no apparent external sanitary venting. Smoke is coming from a pipe at the base of the foundation on the side of the house. The house is vacant, it filled with smoke, indicating open vents or P-traps.
